7 ORDEAL AND RECONSTRUCTION (1914-1931-1958)

1914-1918, the terrible years

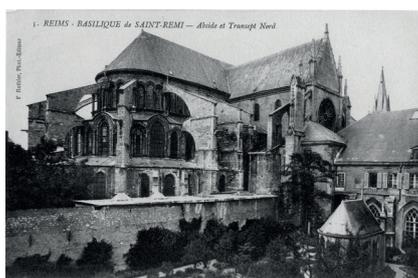
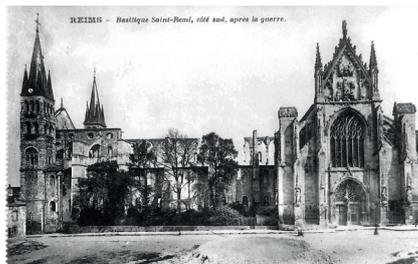
Pictures 34 and 35 – Postcards showing the basilica before and after 1915 – coll. TD

In 1916, the apsidal chapels were destroyed. In 1918, an incendiary projectile set the timber work on fire; the wooden vaults built by Narcisse Brunette in the 19th century were irretrievably lost.

The disaster grew even worse; the war wreaked havoc upon the north tribune, the grand organ, and the choir organ. After the end of the devastating conflict, the south tribune of the nave collapsed, due to bad weather and the lack of inverted pressure.

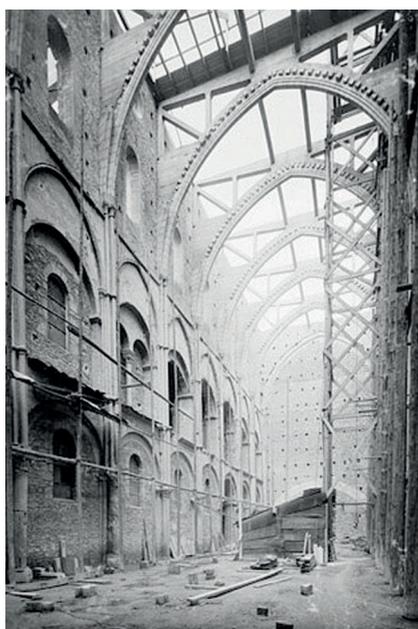
Picture 36 – Reconstruction of the nave (1920s) © Ministry of Culture - Médiathèque de l'architecture du patrimoine (diffusion RMN)

Immediately after the end of the war, in the summer of 1919, German prisoners were requisitioned to clear out the ruins and proceed to the filling of gaps. The cult was resumed sporadically in the north aisle, which was less damaged. From 1921, the south walls were re-erected with the salvaged stones. Stone by stone, the reconstruction required patience and courage. Henri Deneux (1874-1969), an architect from Rheims, was missioned by the City authorities and the National Monuments Organisation to reconstruct the religious monuments of the city. Thanks to his research on medieval techniques and how to adapt Philippe Delorme's timber work methods, the framework was made lighter and the work time reduced.
